**Flood Control Project Maintenance
Levee Inspections**

Maintenance Issue Types Only, Levee Inspection Report By Mile - Spring 2015

Sutter Maintenance Yard Maintenance Area 0017

Waterway	Bank	Unit Miles	Inspection Start/End	Inspector
Unit No. 01 Lake County Sutter Maintenance Yard - Middle Creek	Left	3.87	03/12/2015 03/12/2015	Bob Duffey

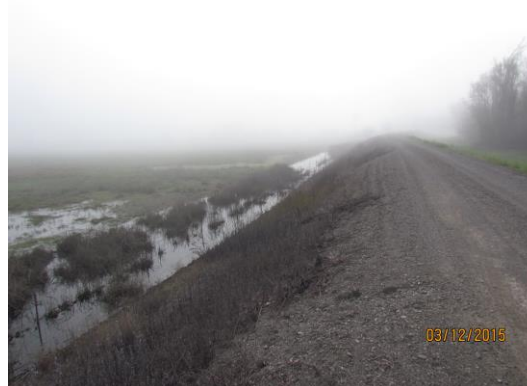
Photo 1 of 1 : SP_2015_MA0017_339_476_20150406_00095.jpg

LM Start	3.80	Rating **	A	Issue No.	476
LM End	3.80	Issue Type +	Ma	Location *	LS
Category	Earthen Levee			GPS Latitude/Longitude	
				Start	End
Item	Vegetation			39.144495 °	39.144495 °
				-122.906355 °	-122.906355 °
DWR ID	DWR_MA0017_01_s _ 2015_476				
Action/Comments					
Control annual grass and weeds on the levee slopes and easements. Inspector Comments: Sutter Yard sprayed the landside slope.

View of the Sprayed slope by Sutter Yard.

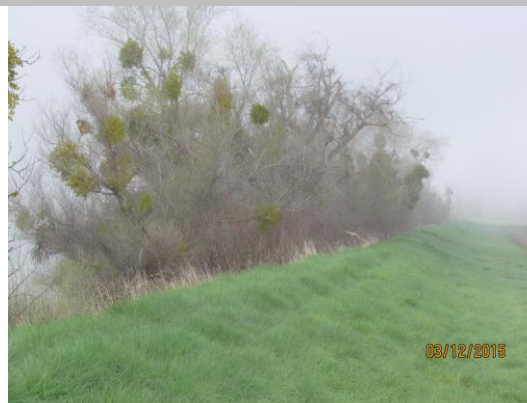
Photo 1 of 1 : SP_2015_MA0017_339_2_20150406_00101.jpg

LM Start	4.09	Rating **	U	Issue No.	2
LM End	7.23	Issue Type +	Ma	Location *	WS
Category	Earthen Levee			GPS Latitude/Longitude	
				Start	End
Item	Trim / Thin Trees			39.142155 °	39.118735 °
				-122.902343 °	-122.884892 °
DWR ID	DWR_MA0017_01_s _ 2012_2				
Action/Comments					
Thin trees to allow visibility of the ground and room to flood fight.

View of the trees along the waterside slope and toe.

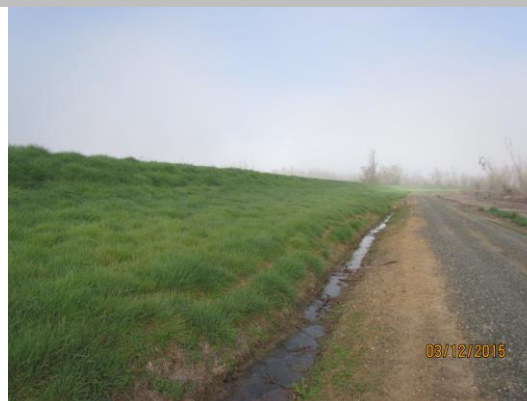
Photo 1 of 1 : SP_2015_MA0017_339_1_20150406_00100.jpg

LM Start	4.09	Rating **	A	Issue No.	1
LM End	7.23	Issue Type +	Ma	Location *	LS
Category	Earthen Levee			GPS Latitude/Longitude	
				Start	End
Item	Vegetation			39.142155 °	39.118675 °
				-122.902343 °	-122.884772 °
DWR ID	DWR_MA0017_01_s _ 2015_1				
Action/Comments					
Remove the wild growth other than native grasses from the levee slopes.

View of the native grasses along the landside slope.
